# Manhole Inspection Summary

Manhole # S41W1\_001MH

Insp Date: **11/30/07 10:59 AM**

**Location** Address: **3500 7th St**

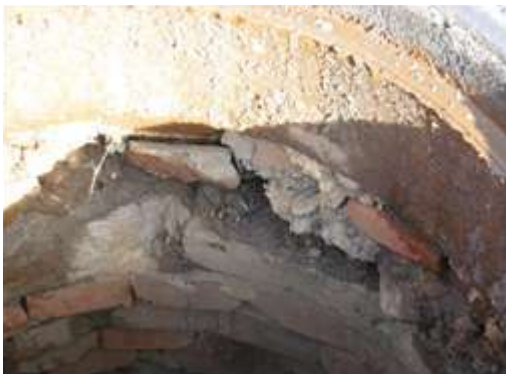
Defect 1

Condition: ☐ Sound ☐ Cracked ☐ Root Intrusion ☒ **Loose Brick** ☒ **Deteriorated**

loose bricks on chimney

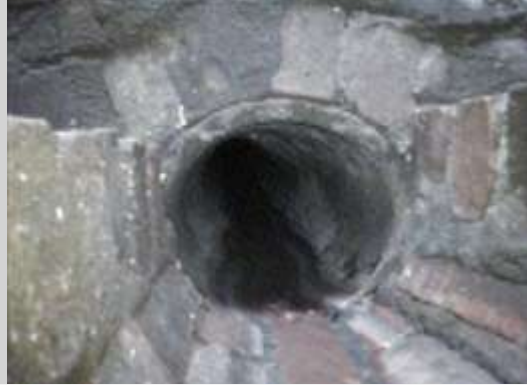
12 O'Clock Outflow

8 in. Circular Gravity Sewer  
Pipe Out @ 12 O'Clock

Pipe Height: **9.6** (in.) Rod and Bar (Angled)  
Pipe Material: **Clay** ☐ Pipe Lined  
Invert Depth: **8.34** (ft.) Flow Characteristics: **Fast**  
Deposits: ☒ None ☐ Mud ☐ Sludge ☐ Debris ☐ Grease  
Silt Depth: (in.) Deposits Extent:  
Infiltration: **None** Pipe Seal Cond: **Sound**

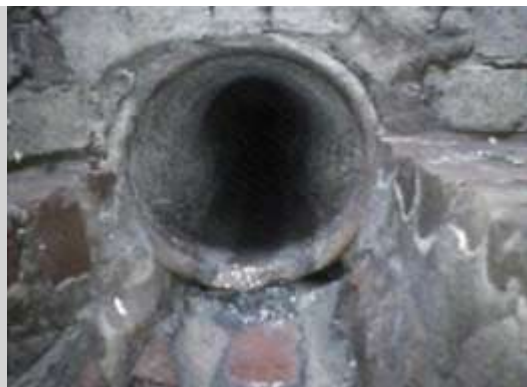
3 O'Clock Inflow

8 in. Circular Gravity Sewer  
Pipe In @ 3 O'Clock

Pipe Height: **8.4** (in.) Rod and Bar (Angled)  
Pipe Material: **Clay** ☐ Pipe Lined  
Invert Depth: **7.80** (ft.) Flow Characteristics: **Fast**  
Deposits: ☒ None ☐ Mud ☐ Sludge ☐ Debris ☐ Grease  
Silt Depth: (in.) Deposits Extent:  
Infiltration: **None** Pipe Seal Cond: **Sound**

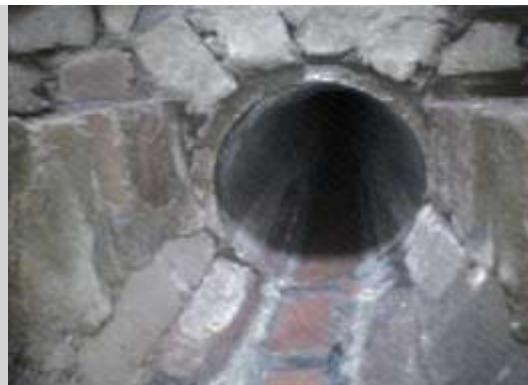
6 O'Clock Inflow

Pipe Height: **7.2** (in.) Rod and Bar (Angled)

Pipe Material: **Clay** ☐ Pipe Lined

Invert Depth: **8.18** (ft.) Flow Characteristics: **Fast**

Deposits: ☒ None ☐ Mud ☐ Sludge ☐ Debris ☐ Grease

Infiltration: **None** Pipe Seal Cond: **Sound**
